Flexible Sustainment Solutions

Demonstrated Examples

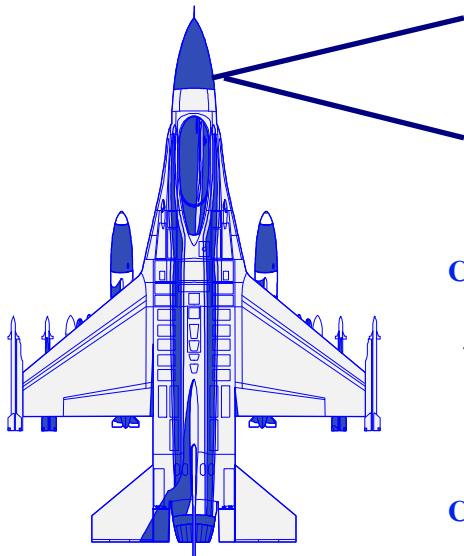
#2. AZ/EL Compensation

After extensive TQS analysis, it was discovered that 70% of all failures in the AZ/EL Compensator were due to thermal runaway.

- ◆ Circuit modification
 - Replace a diode with a jumper wire in four places
